August 30, 2007
Project 04516-2

Geotechnical
Environmental and
Water Resources
Engineering

Re: **Monthly Remedial Monitoring Report No. 4**
50 Tufts Street Site
Somerville, MA
RTN 3-23246

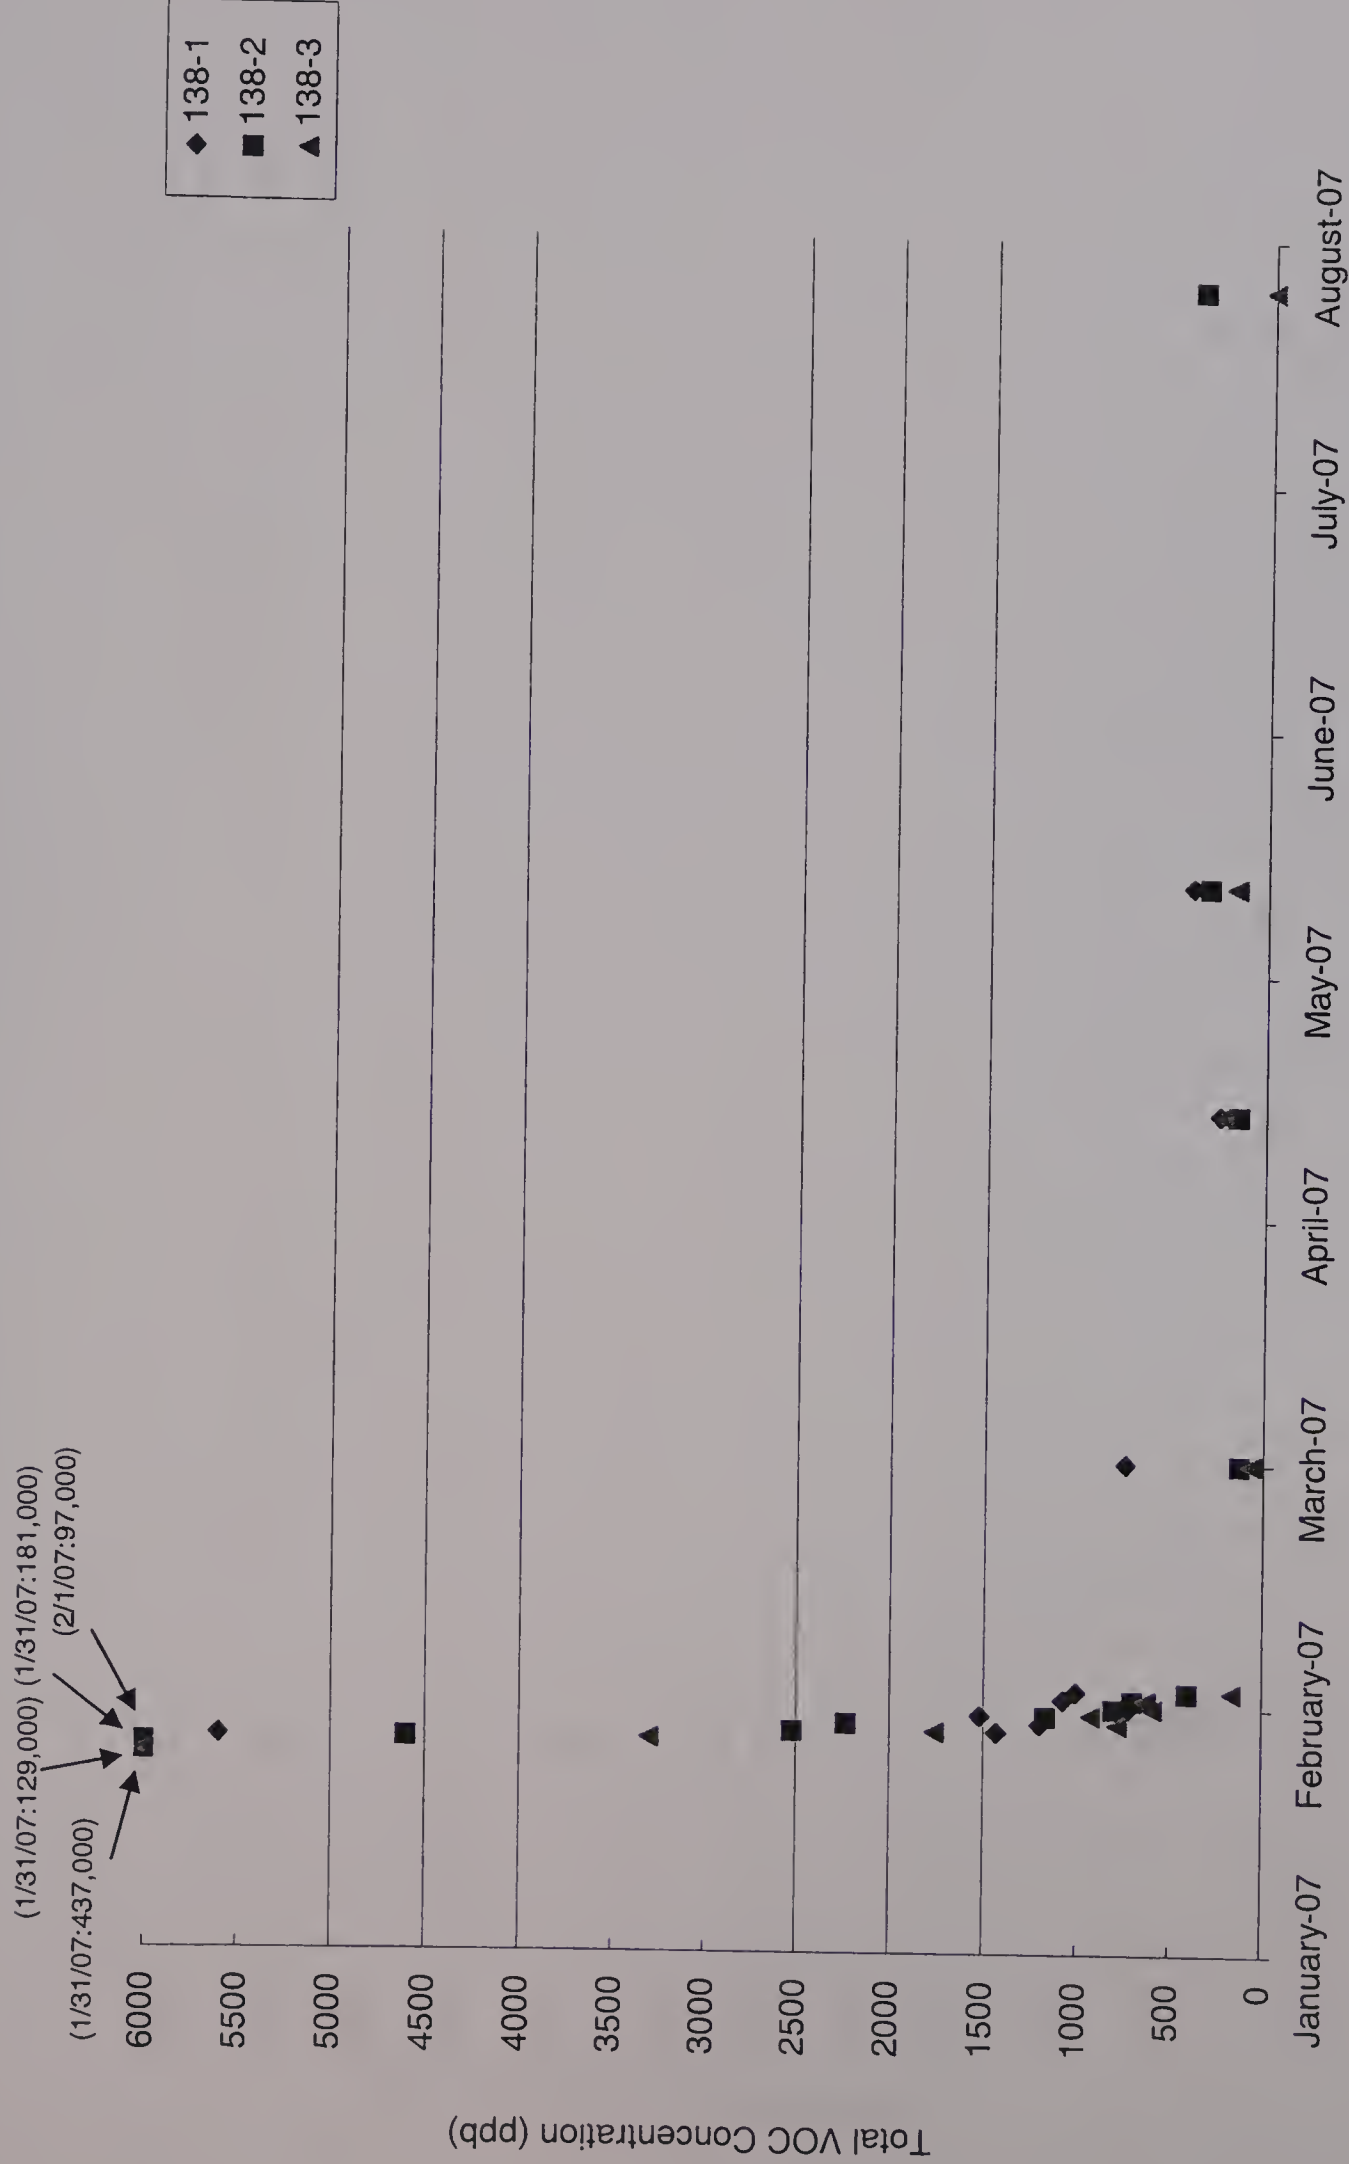
Graph 6

PID Monitoring Data: January 31, 2007 - July 31, 2007
Total VOC Concentrations by PID at Exterior Monitoring Points - Room 138
Capuano Center
Somerville, MA

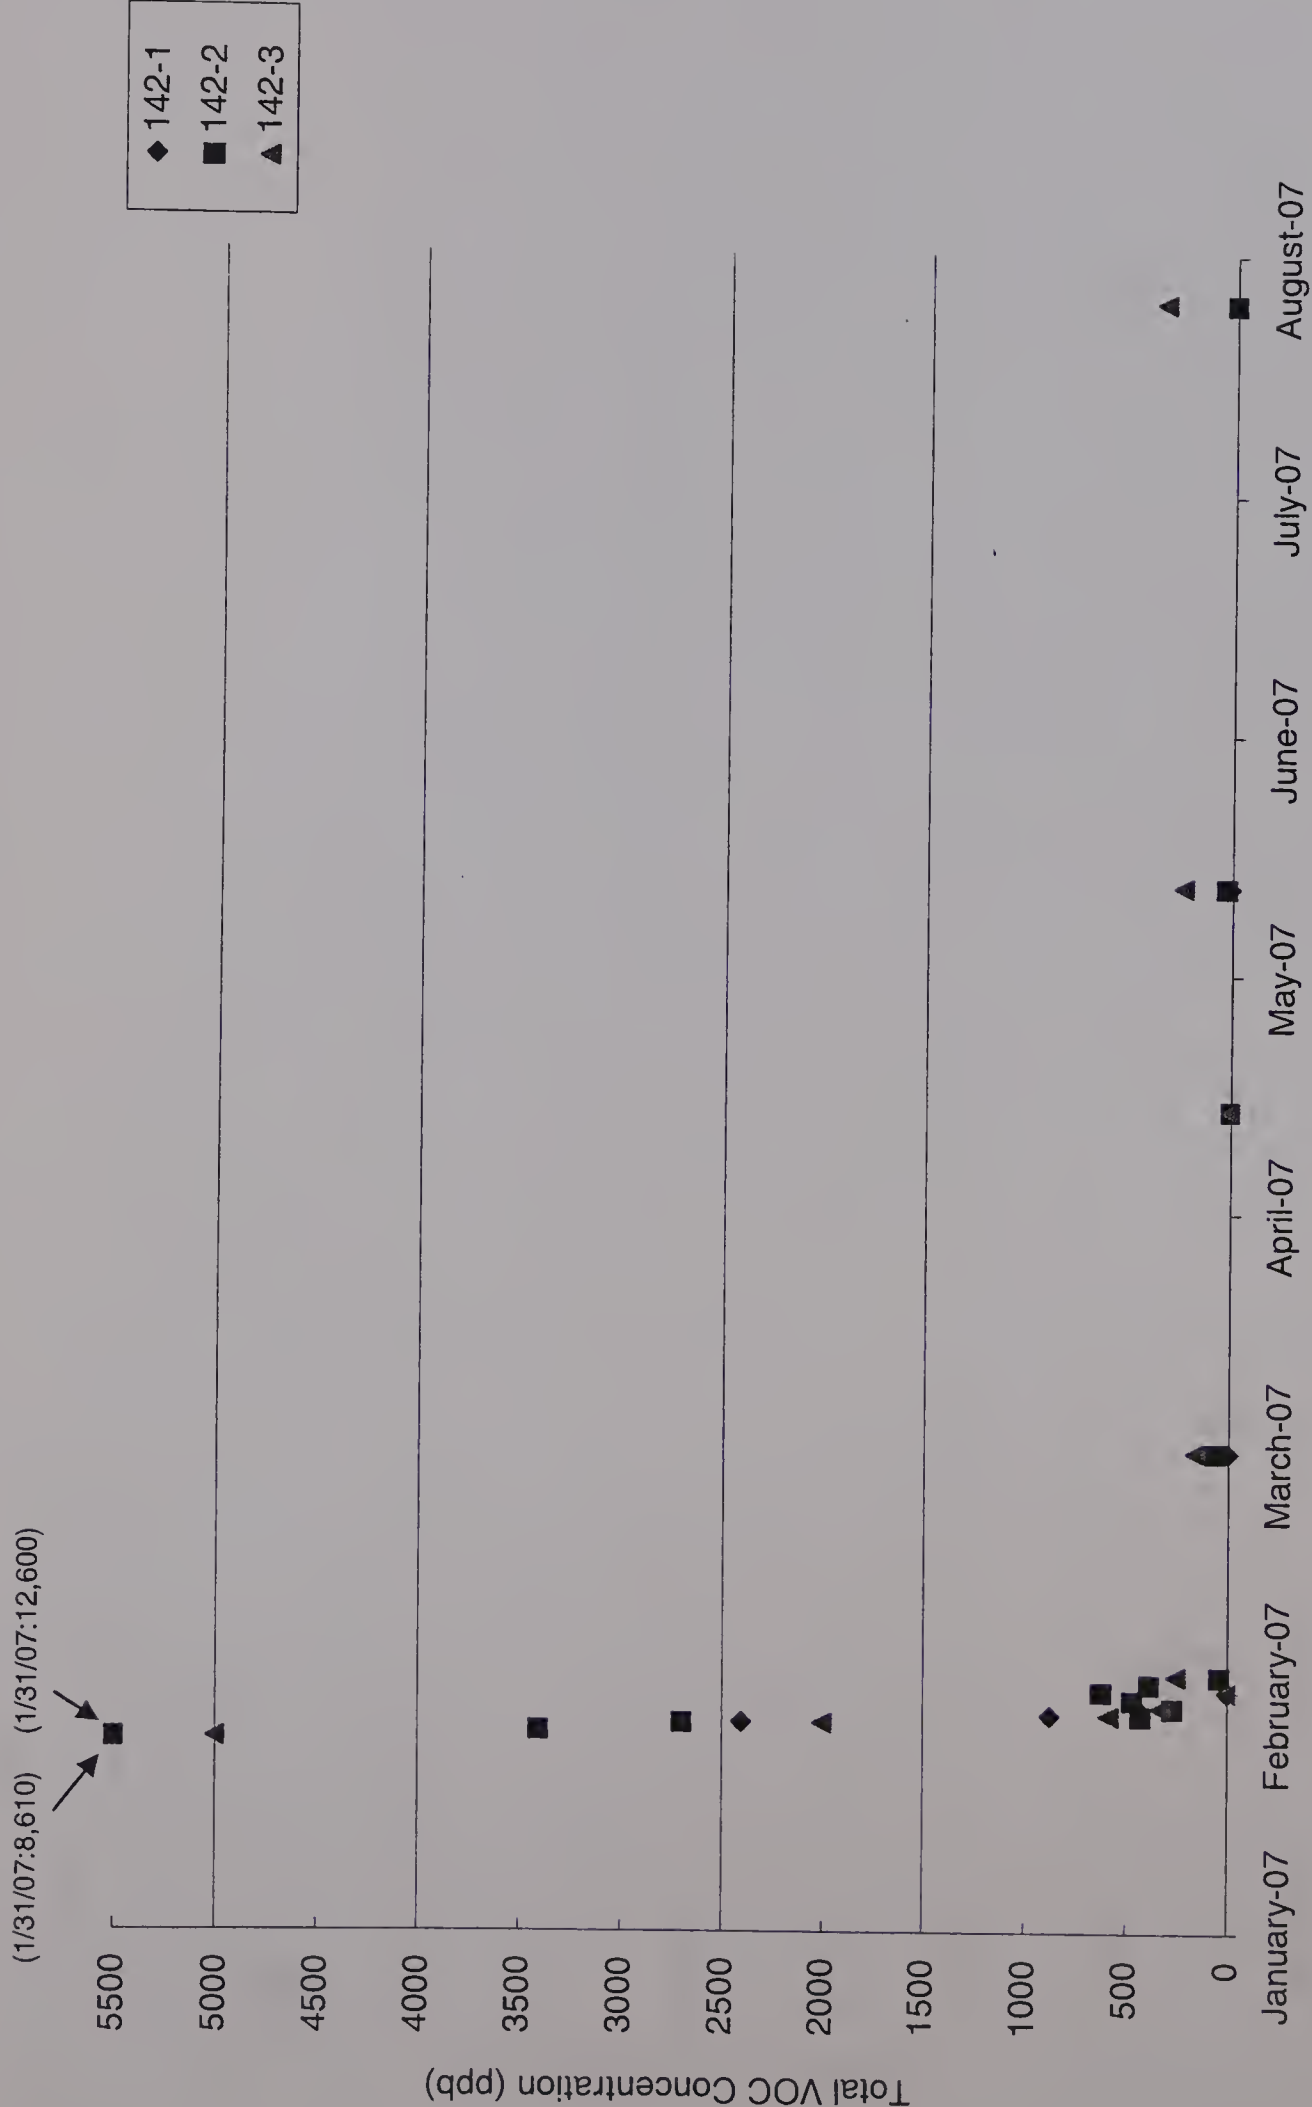
Graph 7

PID Monitoring Data: January 31, 2007 - July 31, 2007
Total VOC Concentrations by PID at Exterior Monitoring Points - Room 142
Capuano Center
Somerville, MA

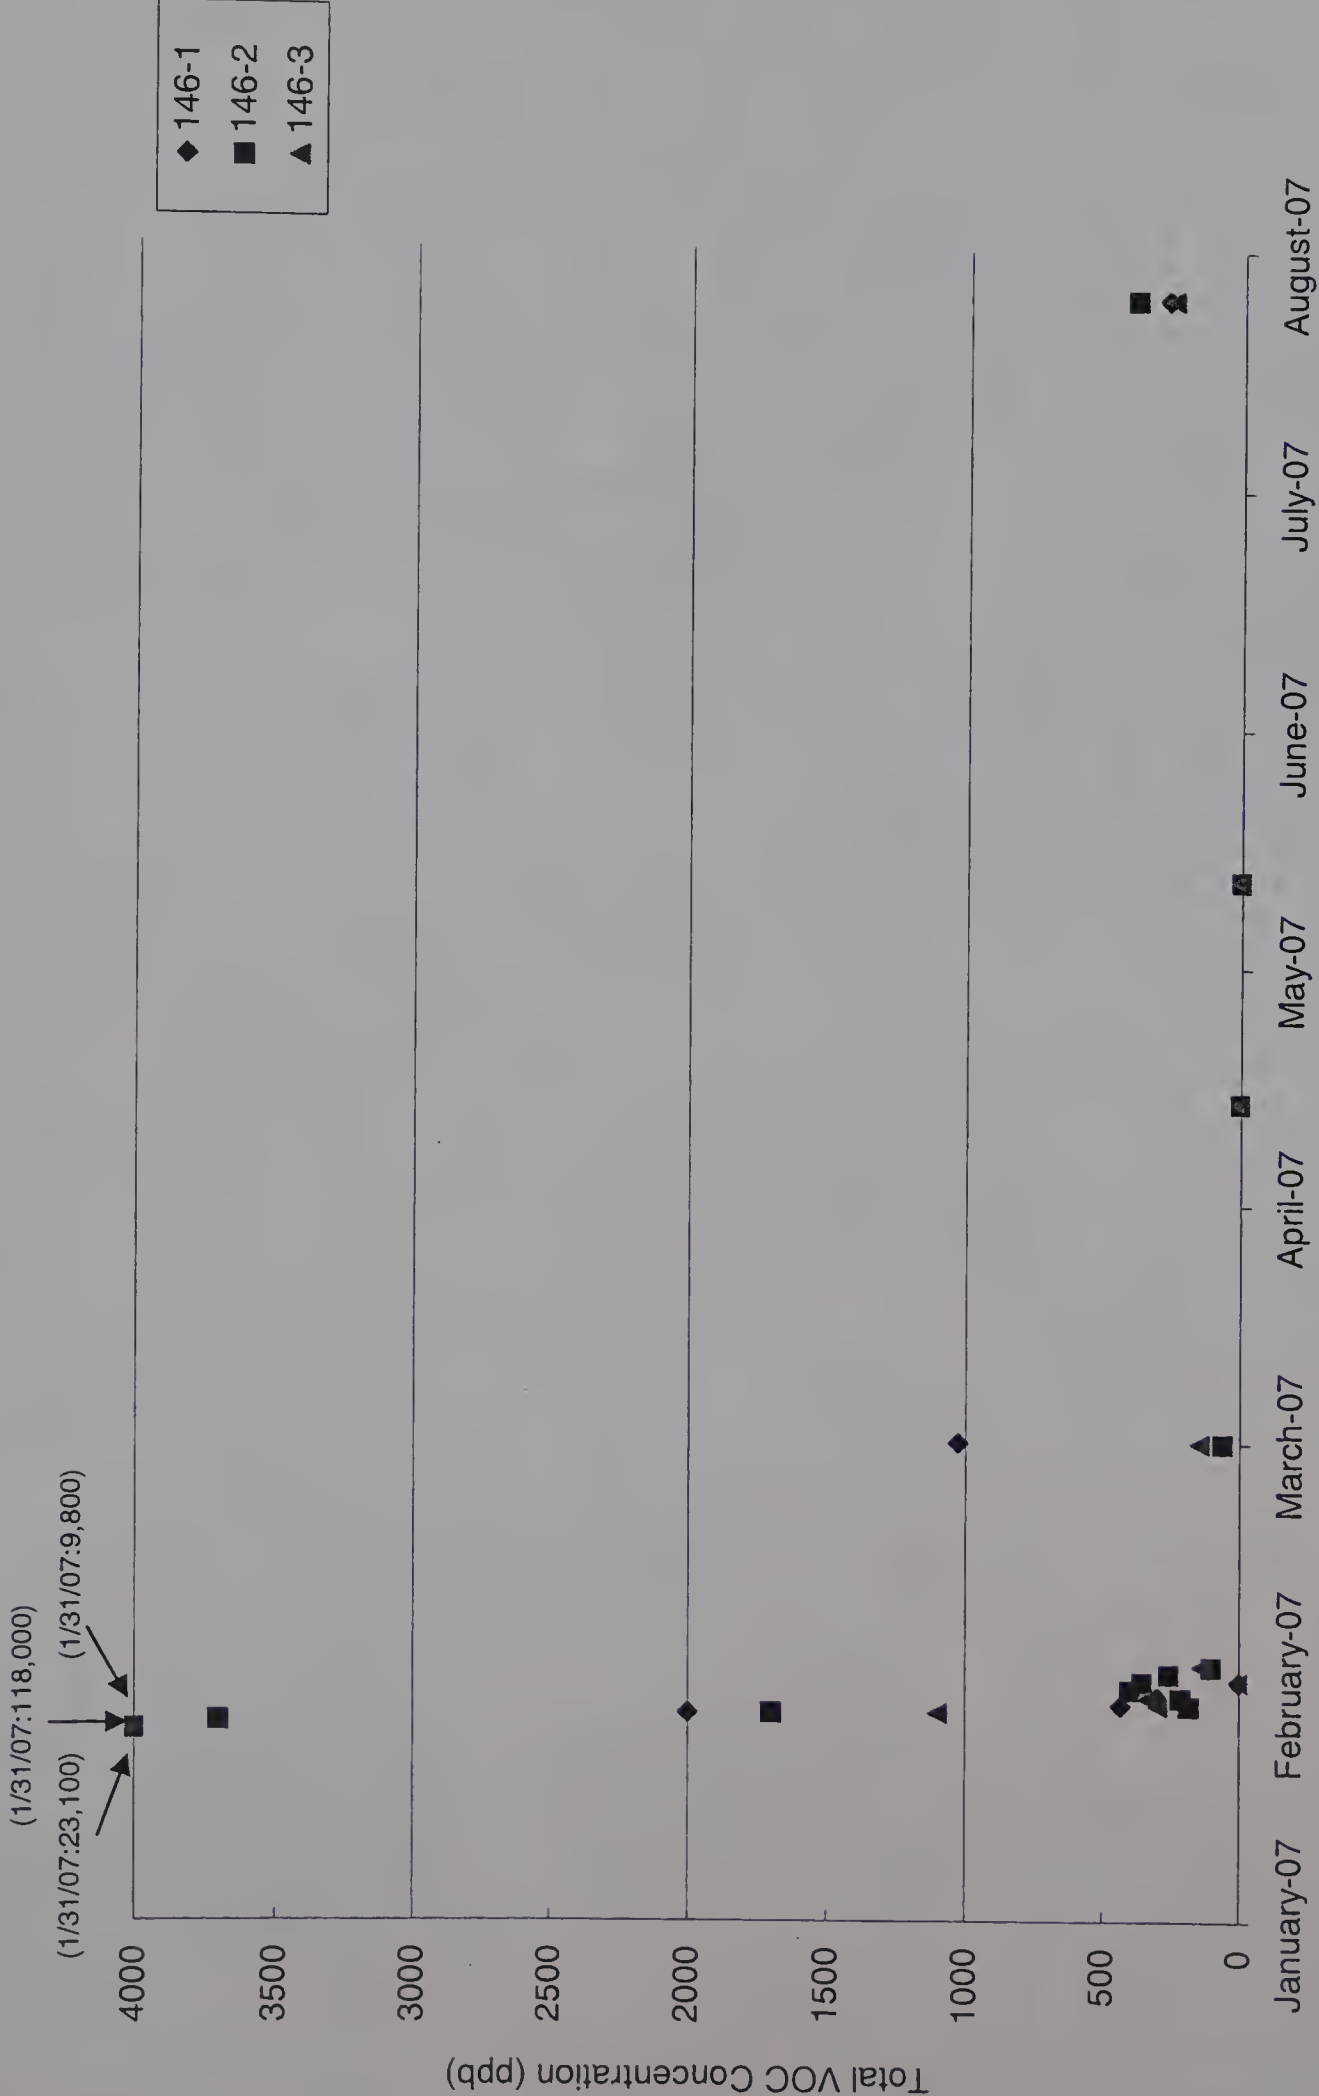
Graph 8

PID Monitoring Data: January 31, 2007 - July 31, 2007
Total VOC Concentrations by PID at Exterior Monitoring Points - Room 146
Capuano Center
Somerville, MA
